## **Grandview and Last Chance Mines - Bat Gating Project**

Grand Canyon National Park

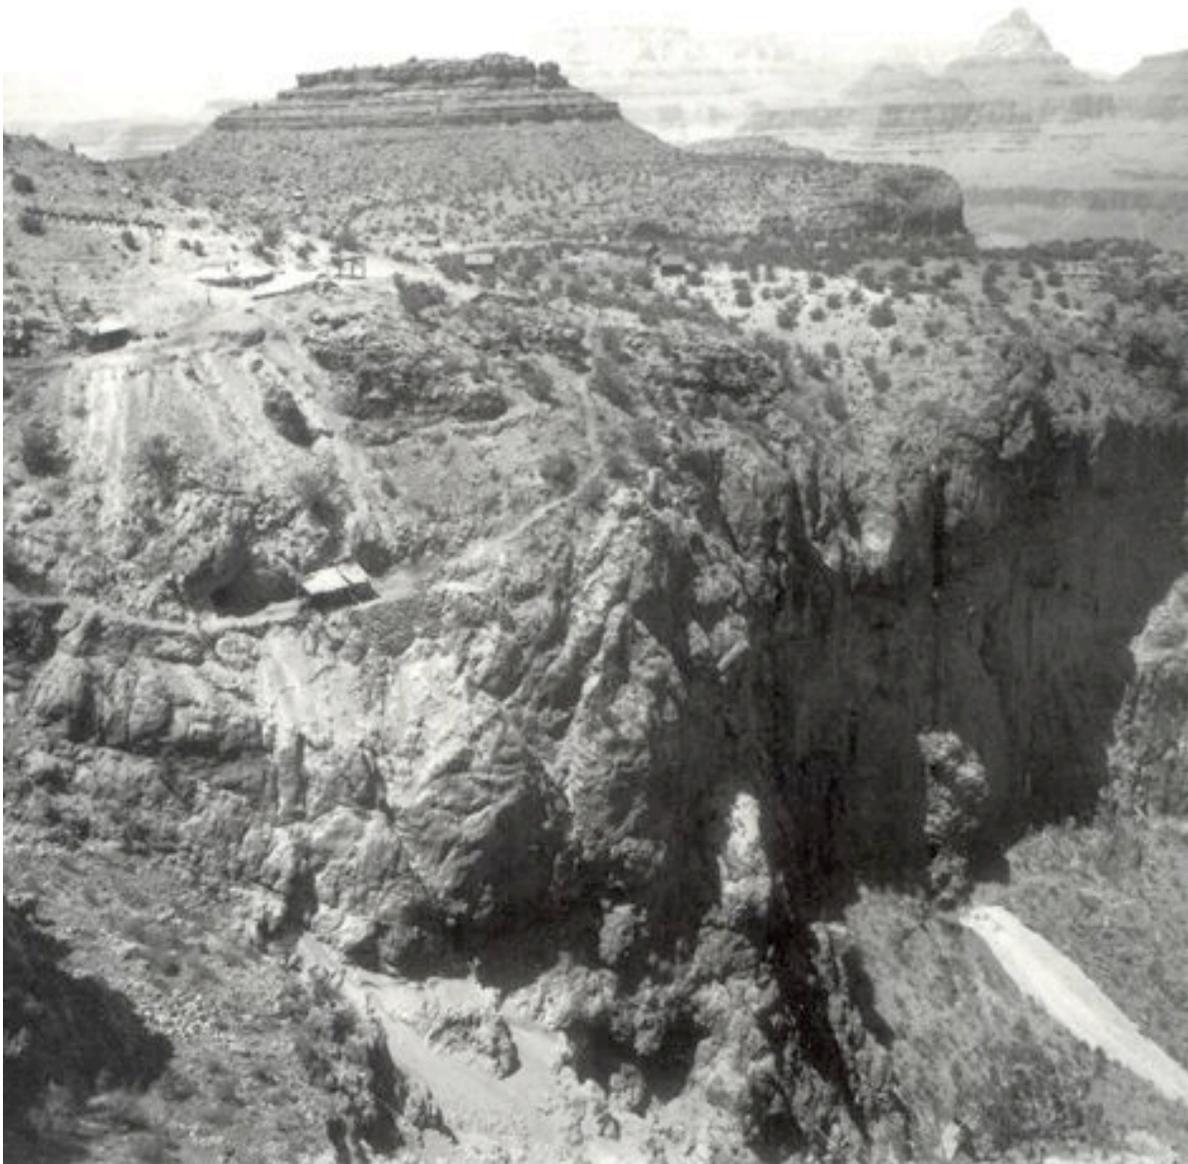
*Grandview & Last Chance Mines, circa 1900*

Located 3,000 feet below the South Rim of the Grand Canyon are the historic copper mines named the Grandview Mine and the Last Chance Mine. The upper part of the photo shows the Grandview mines, and the lower right hand corner of the photo shows the waste rock dump of the Last Chance mine. These mines were first staked in 1890 by prospector Pete Berry. The ore from these mines was hauled out of the canyon daily by a string of mules up the Grandview Trail. Note the mule team in the upper left hand corner of the photo. The ore from these mines was very high quality with some samples exceeding 70% pure copper. But due to the high cost of moving this ore from such a remote location, the mine ultimately closed by 1907.

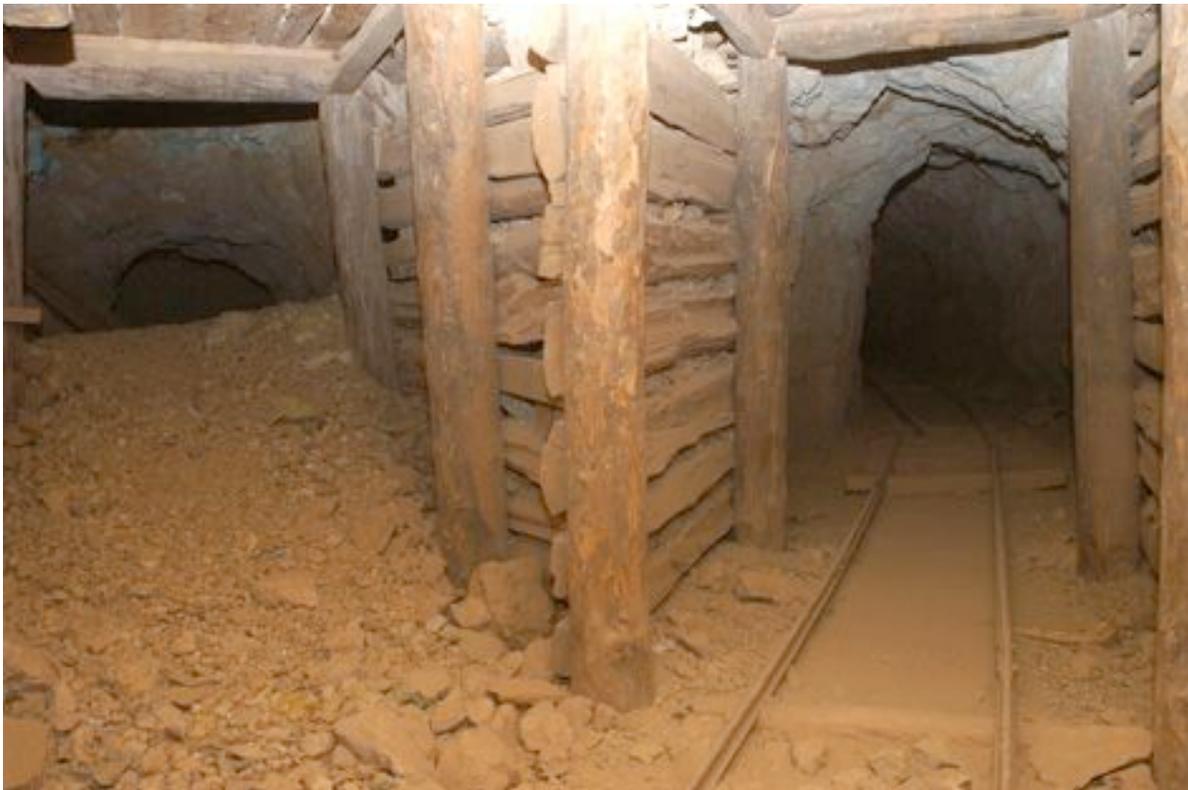
*Collapsing Tunnel in Grandview Mine*

After 100 years, many of the mine tunnels and shafts have collapsed or have become quite unstable. Notice in the photo that the right tunnel is clear, but the left tunnel has dumped a large section of rock and dirt into the tunnel. The miners would install wooden shoring in mine tunnels at locations where they found loose rock. Over time this shoring rots, deteriorates, and collapses sealing the tunnels.

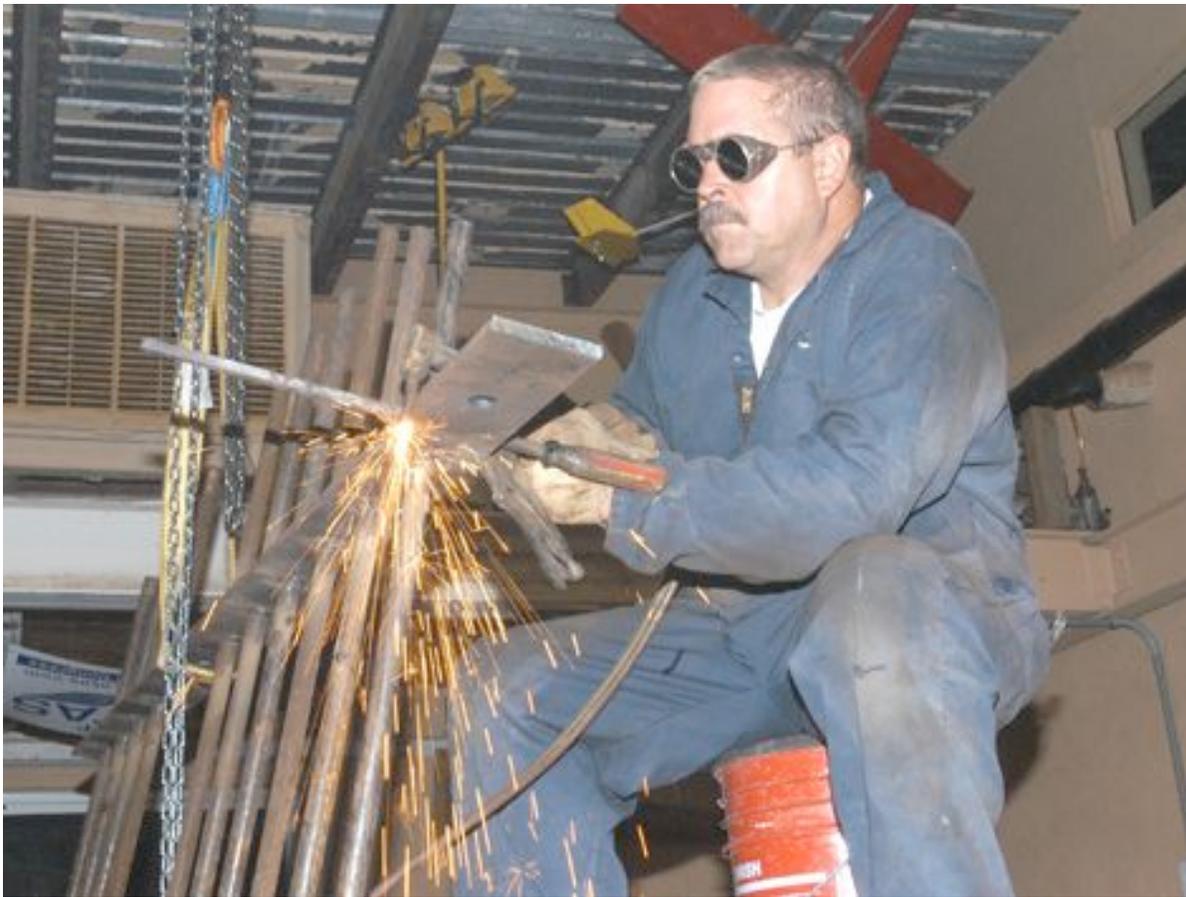
*Trimming Bat Gate*

The upper adit of the Grandview mine required a culvert gate to help support the ceiling from further cave-ins. The culvert gate contains gating bars similar to the adit gates, but must be entered via crawling through the 30 inch diameter culvert.

The entrance section of the gate is designed to have easy access when open, and allow enough space to pass a rescue litter through the gate entryway. On each gate we installed our secure P-Locking system, along with a heavy duty Medico high security lock. Final modifications to the gate are made onsite to fit the specific mounting location.

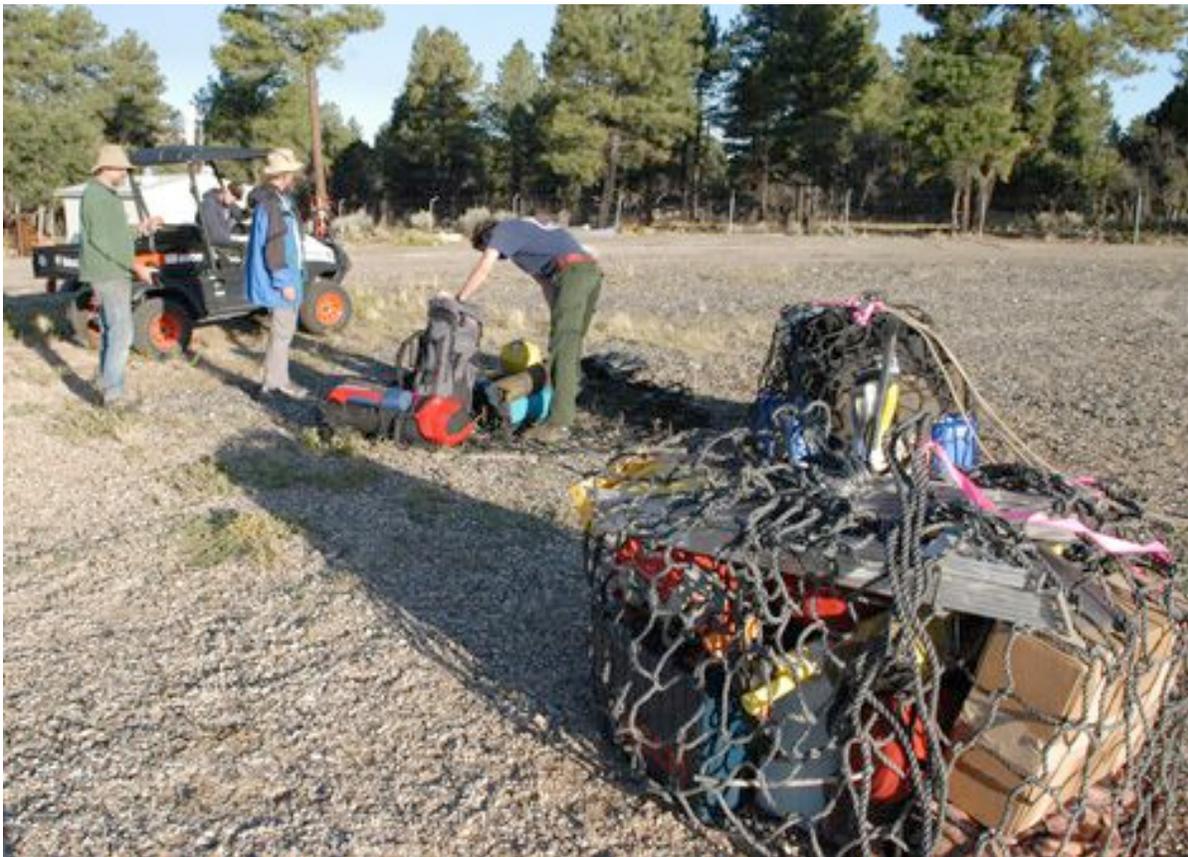
*Organizing Gear into Helicopter Cargo Nets*

To prepare the tools, gear and gates for helicopter transport our group had to weigh and mark each specific item. Then the items were organized by the four different drops points, and then placed on cargo nets as shown. Each load must weigh less than 800 pounds for the helicopter to safely transport. This project required seven placed loads, and five removed loads at the end of the project.

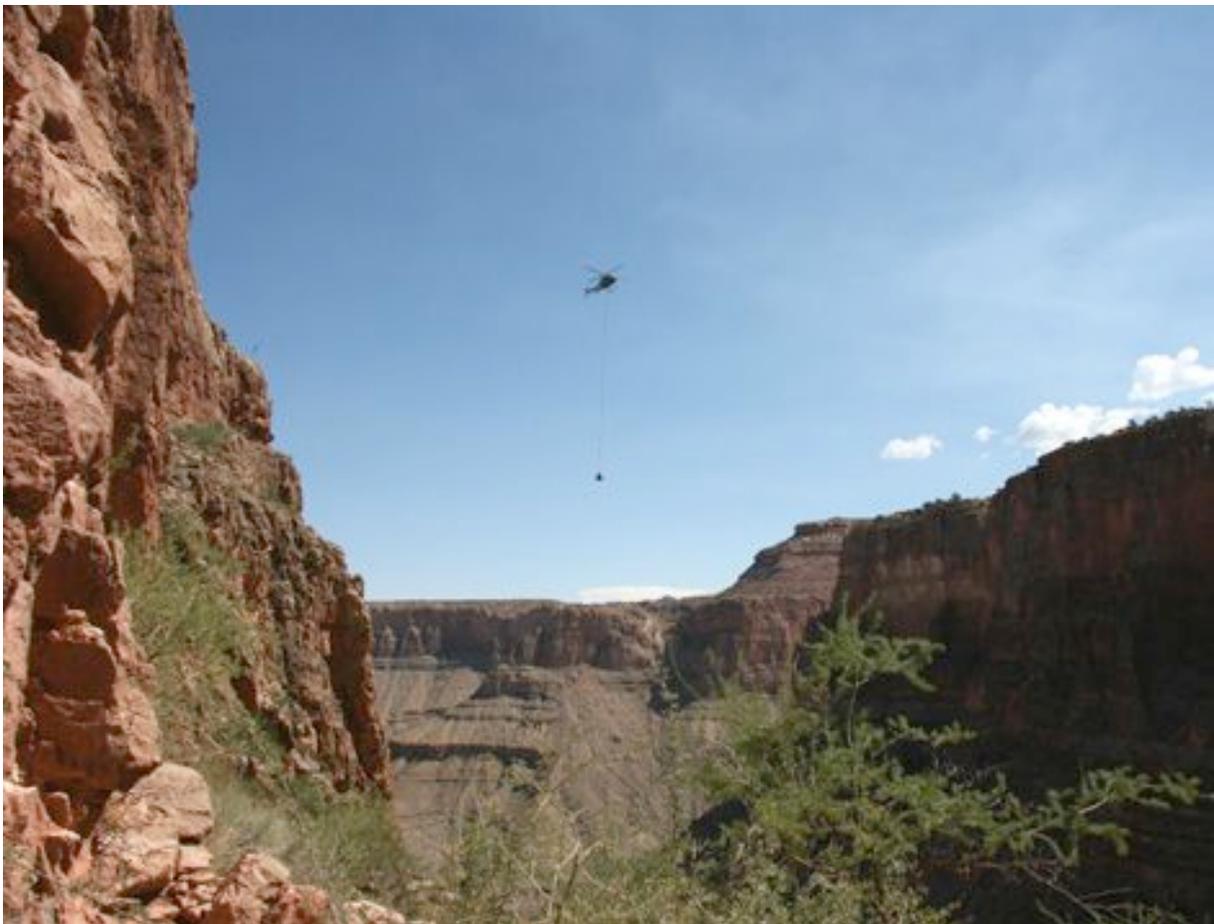
Helicopter Hauling Equipment to Last Chance Adit

The middle Grandview adit and the lower Last Chance adit were much more challenging. These adits were situated mid-cliff and only had flat target areas of about 8 feet wide trails right next to the cliff. The helicopter was able to hover very near the cliff wall and place these cargo nets and gates right on target. One or two feet off and our gear would be bouncing down the canyon, but the helicopter pilot is an expert and our gear arrived safely. This successful delivery also shortened our schedule as we had originally planned to drop all our gear and gates on top of the mesa and lower it over the edge by roped haul systems.

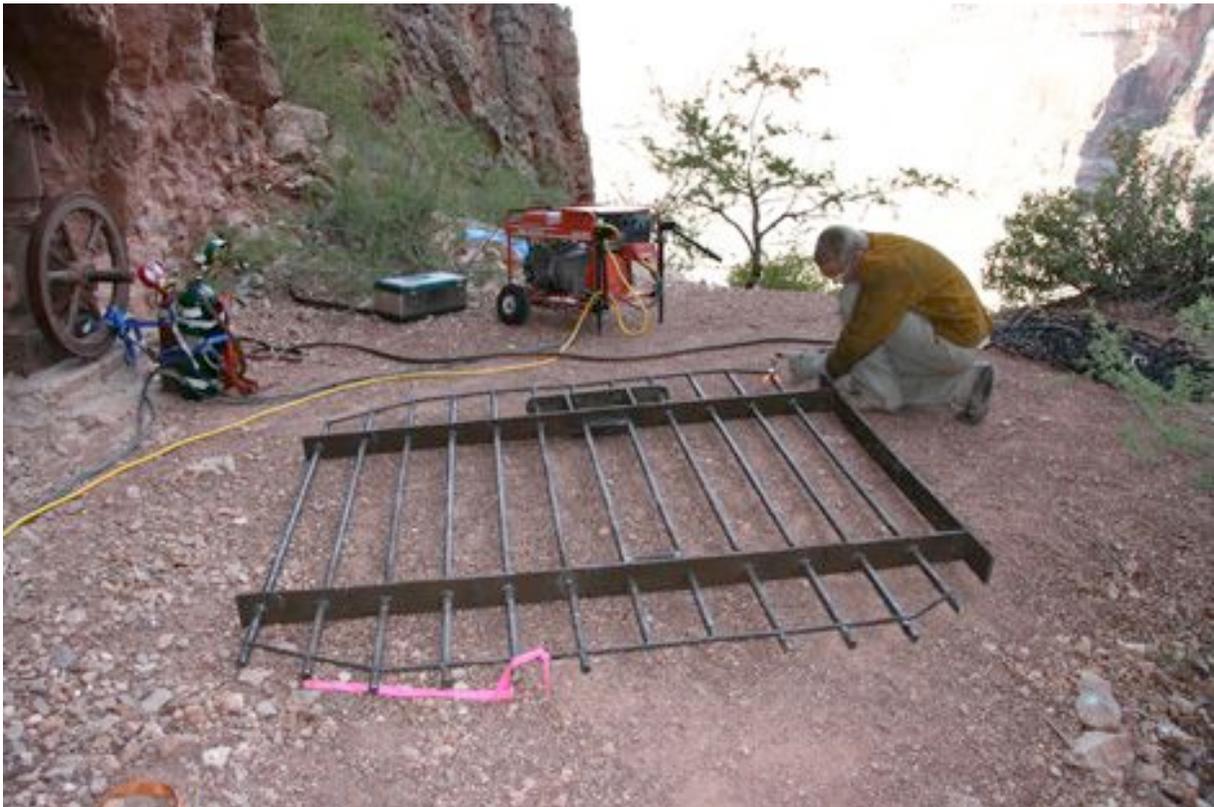
Trimming Bat Gate

Once the gates and tools are onsite, each team would fit the gate to it's specific location in the adit. Normally the gate would need to be trimmed or expanded depending on the adit walls. Trimming is done with the "portable" cutting torch as shown in the photo. When our middle Grandview mine adit torch broke, we had to shuttle this 70 pound "portable" cutting torch up from the lower Last Chance Adit. Fortunately, we planned ahead and brought along backup tools. Depending on the airflow of the adit, sometimes it is best to do torch trimming work outside of the tunnel.

Large gates such as this one require two to three workers to manuever the gate into place. The hammer drill used for drilling holes for the mounting pins, also acted as a chissel for widening spots along the adit walls. Large prybars and light sledehammers are also useful pursuading the gate into it's final position.

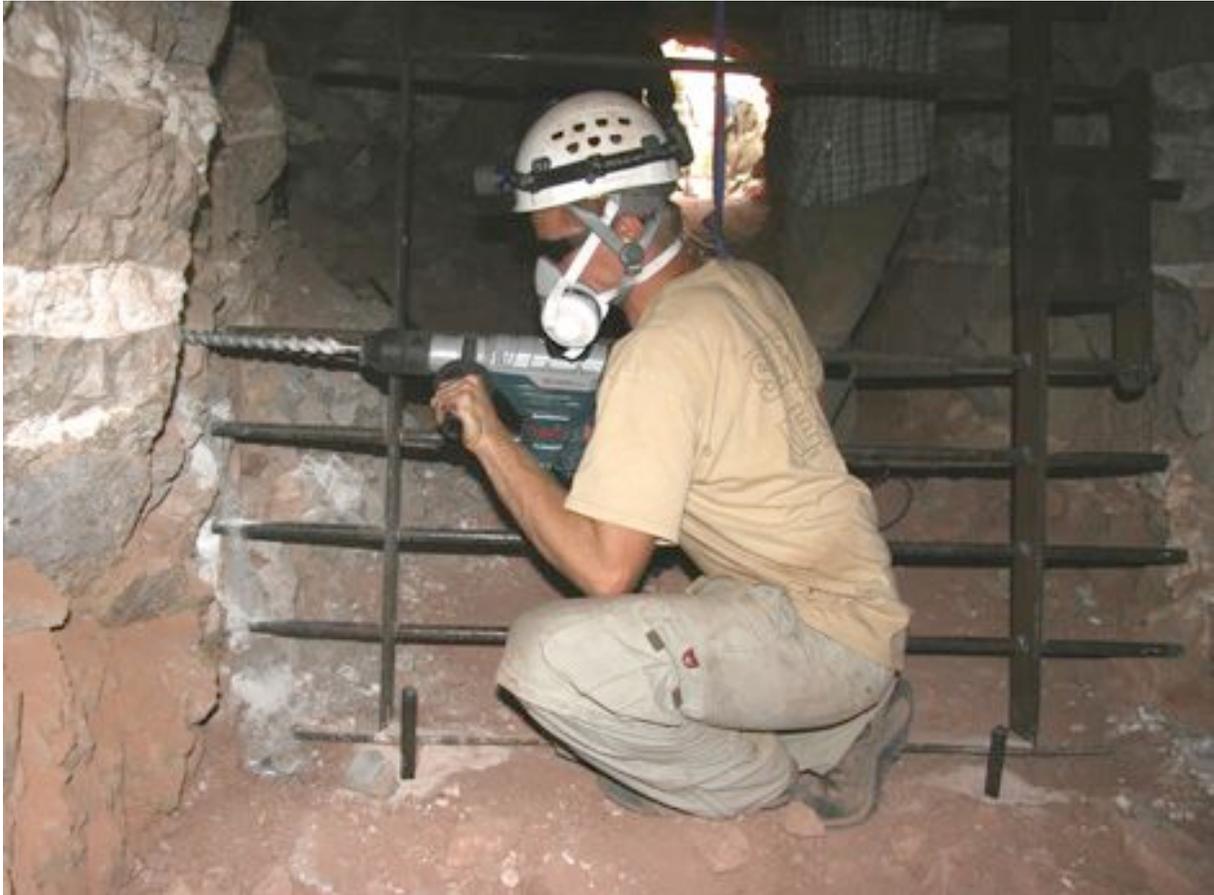
### Drilling Holes for Steel Mounting Pins

After the gates are fitted at their specific location in the adit tunnel, the walls are marked for the mounting pins. In this picture we are drilling one inch holes that will hold the mounting pins for the gate. These 12 inch long pins are then pounded into the wall and later clamped and welded to the gate. Much longer pins are placed into the floor and are also welded to tabs on the base of the gate.

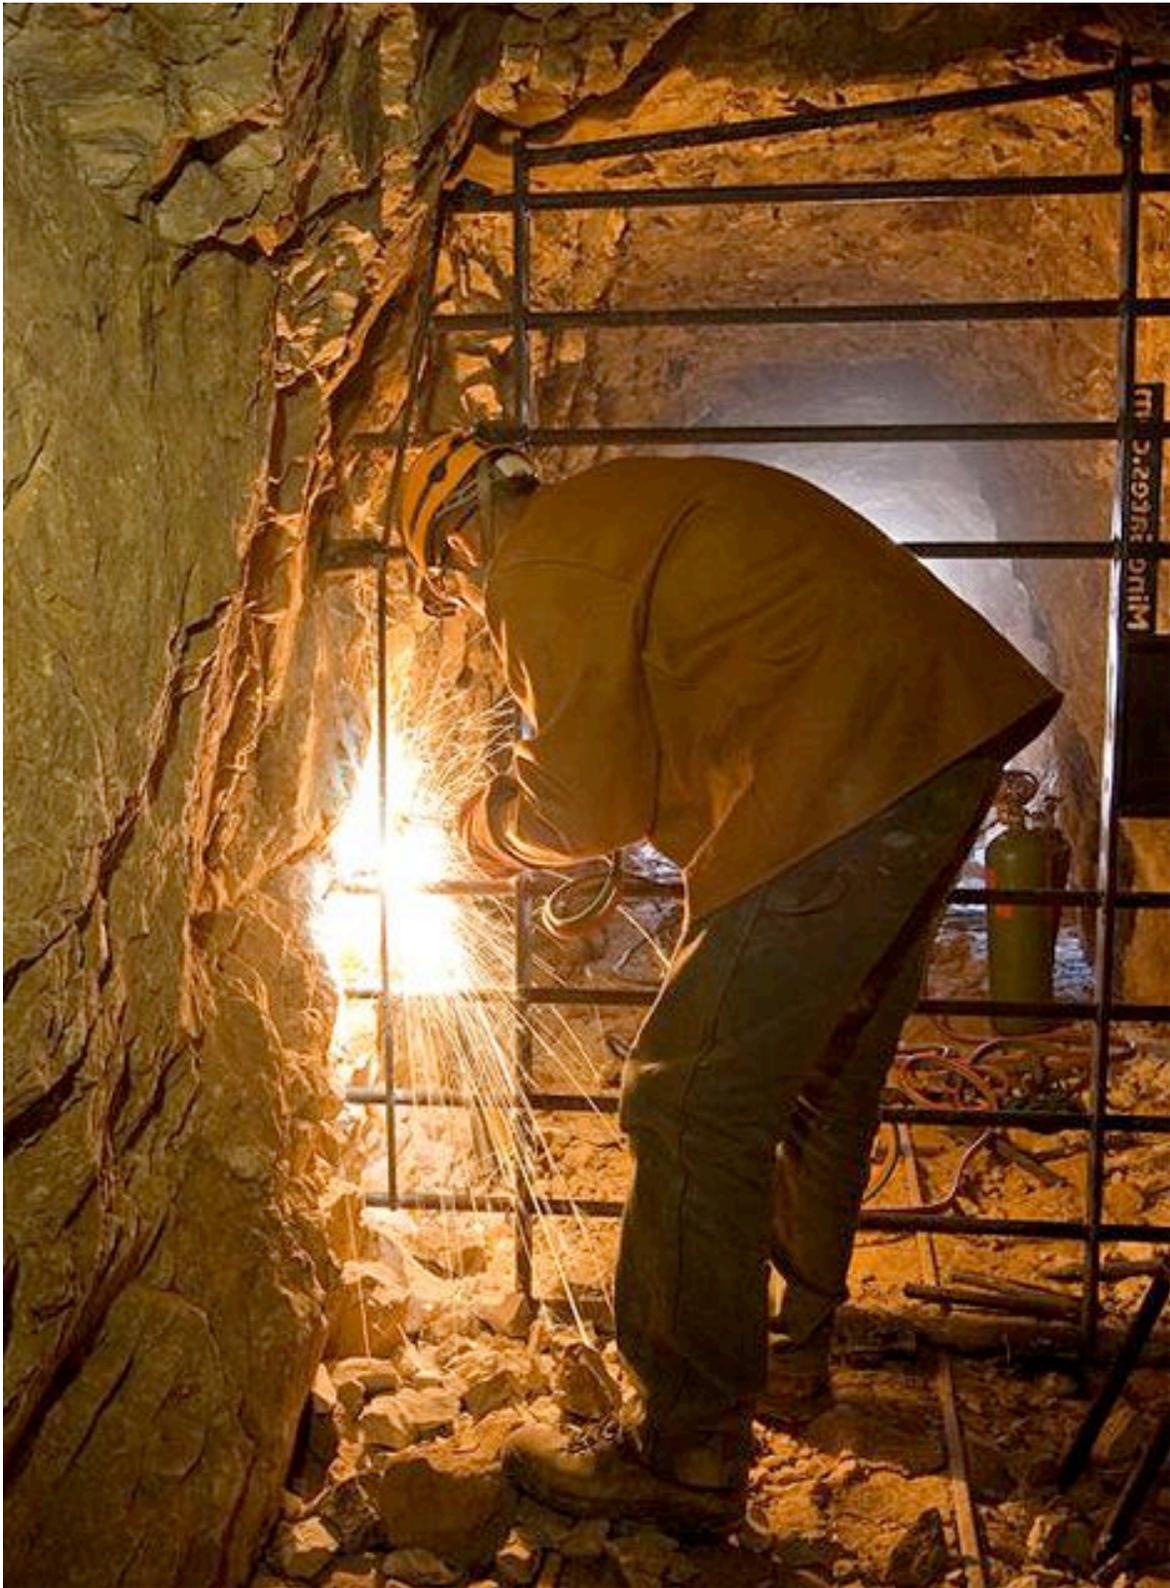
Bat Gate Mounting.

This image shows the final mounting work of the middle adit of the Grandview mine.

Excess steel is trimmed off with the torch, and mounting pins are welded to the gate frame. The outside edge of the frame is checked for gaps along the adit wall, and extra steel braces are welded in place as needed. Any rough edges near the bat flyway gaps between the bars are ground smooth. Rough and sharp edges on a bat gate can tear bat wings as they fly through the portal.

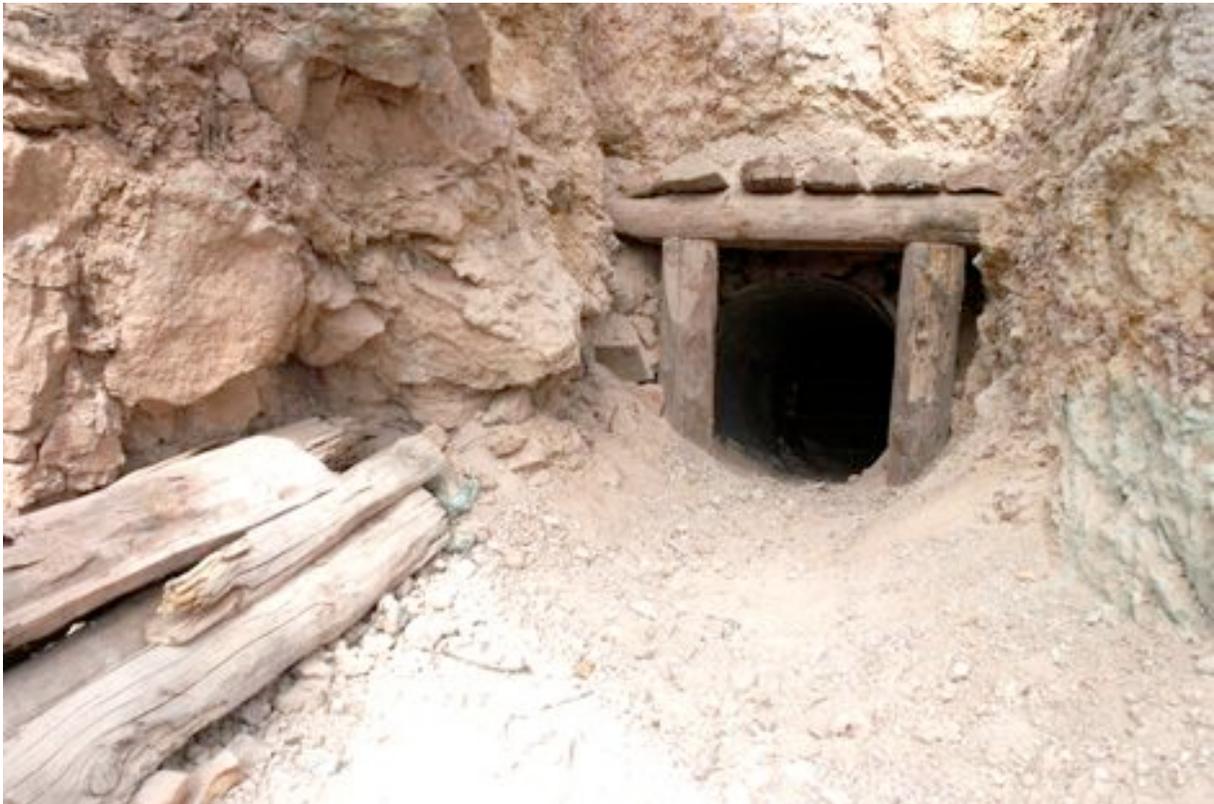
Culvert Gate with Historic Shoring Timbers

The photo below is the final view of the upper adit of the Grandview mine. The original entrance shoring timbers of this mine have been rebuilt over the culvert entrance. The excess timbers are stacked outside as if ready for a 1900's shoring project.

The 30 inch culvert will provide stability for the collapsing entrance, and ensure a portal for the Townsend's Long-eared bat colony using this entrance to the mine. To avoid later infilling, the entry path leading up to this portal has been dug down in a sloping manner so that water drainage flows away from the entrance.

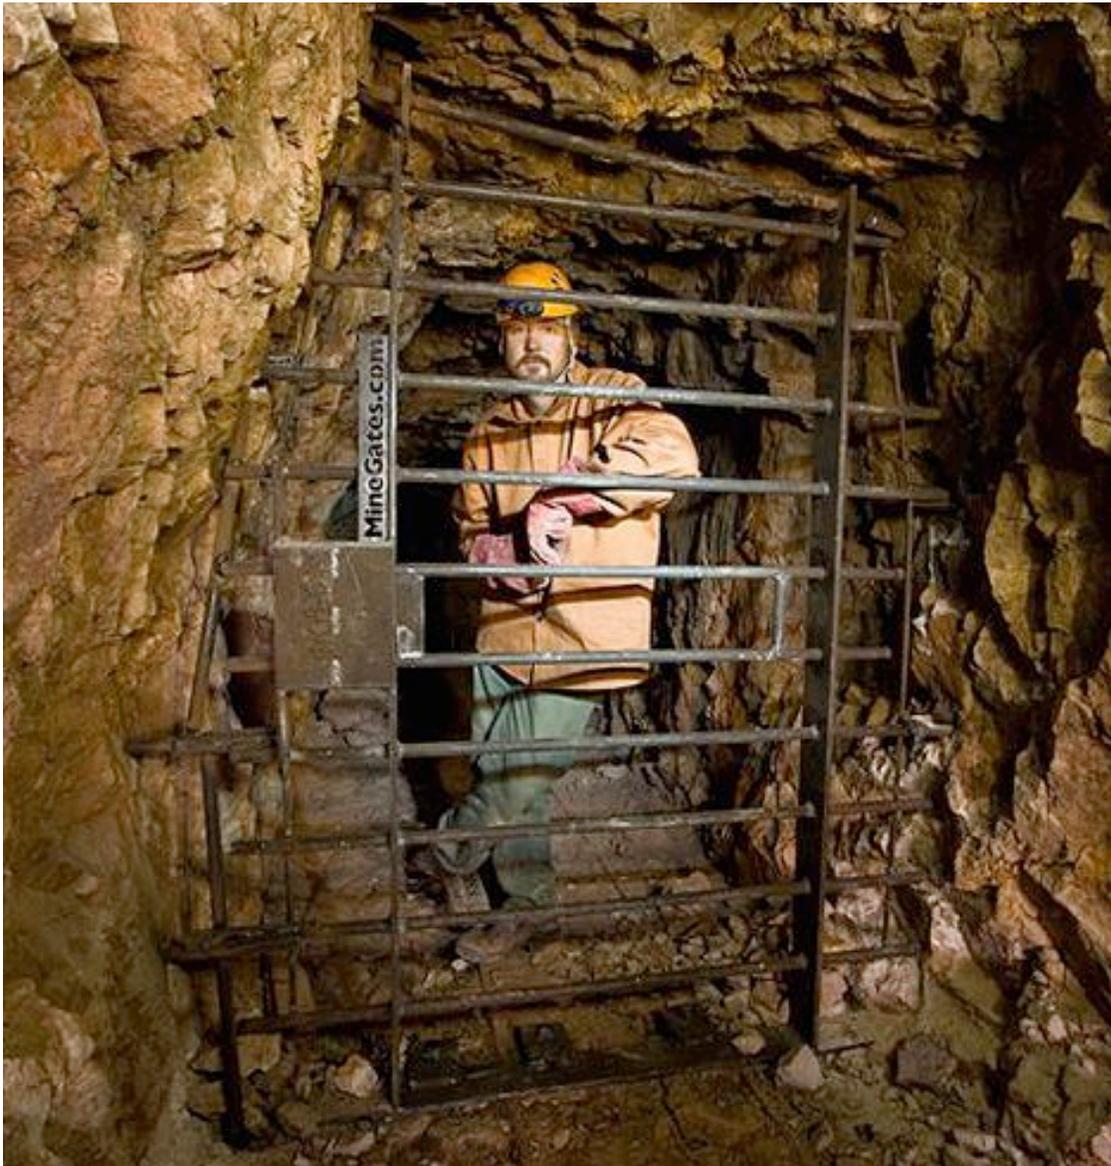
The view below is of the final gate in the middle adit of the Grandview Mine. Note the heavy lock box on the left side of the gate, and the customized outer frame contouring the tunnel walls. Installation of all three gates were completed in about a day and a half to minimize impact to the park.
