## **Whispering Ranch Mine - Bat Gating Project**

Located on BLM land outside of Wickenburg, Arizona.

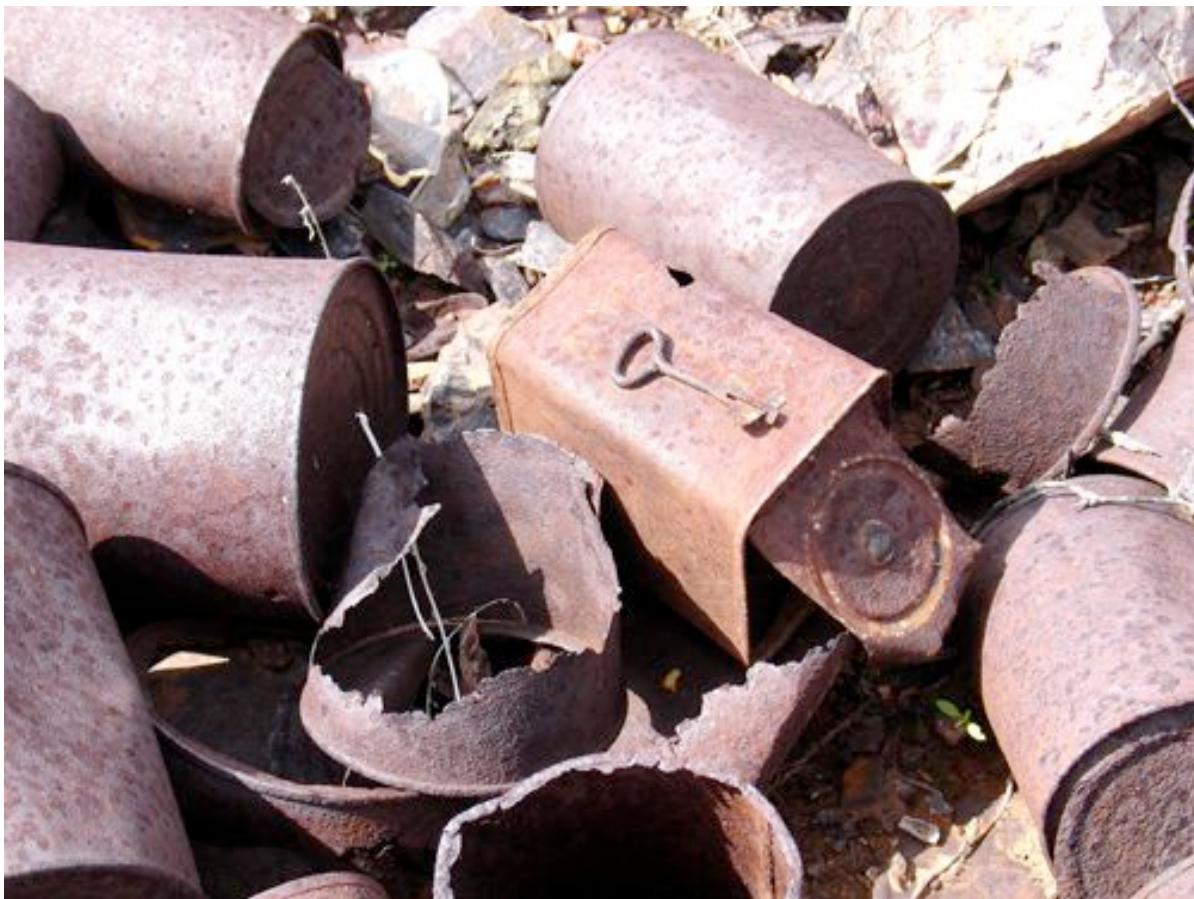
*Trash Dump at Mine Site*

When we first visited the site in the fall of 2009 we noted that there were limited existing remnants of this significant mine site. Nothing is left of the headframe, processing structures, or living facilities of the past workers. All that is left is the large dump rock piles, a few concrete hoist bases, and a deep clear shaft encircled with a simple steel fence. As is the case with many old mines, when work is ceased at a specific site, the wood, tools and machinery are packed up and reused at the next promising location.

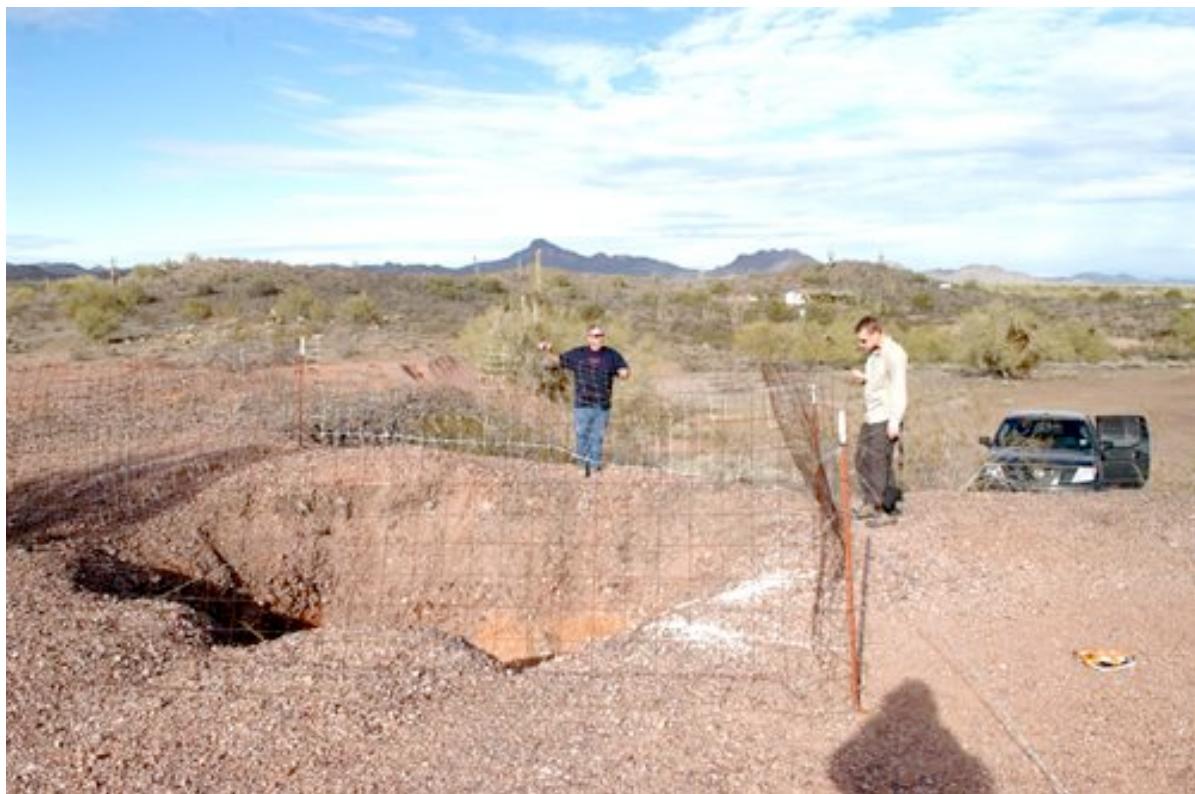
*Original Fenced Vertical Shaft*

The shaft itself is a straight vertical drop of at least 180 feet down to some complex wooden cribbing. Near the bottom is a horizontal drift that was dug following the ore body. The complex cribbing at the bottom of the shaft may be the remnants of a trap door system that enabled the miners to dig and work much deeper, while protecting them from falling debris. Even a small rock falling 180 feet straight down a shaft can kill a miner. Timber cribbing was also installed in shafts when the miners would encounter soft rock in the walls. As you can see in the photo below, the upper rock is fairly strong and has seemed to stay solid for the last 100 years. This does not mean that this mine

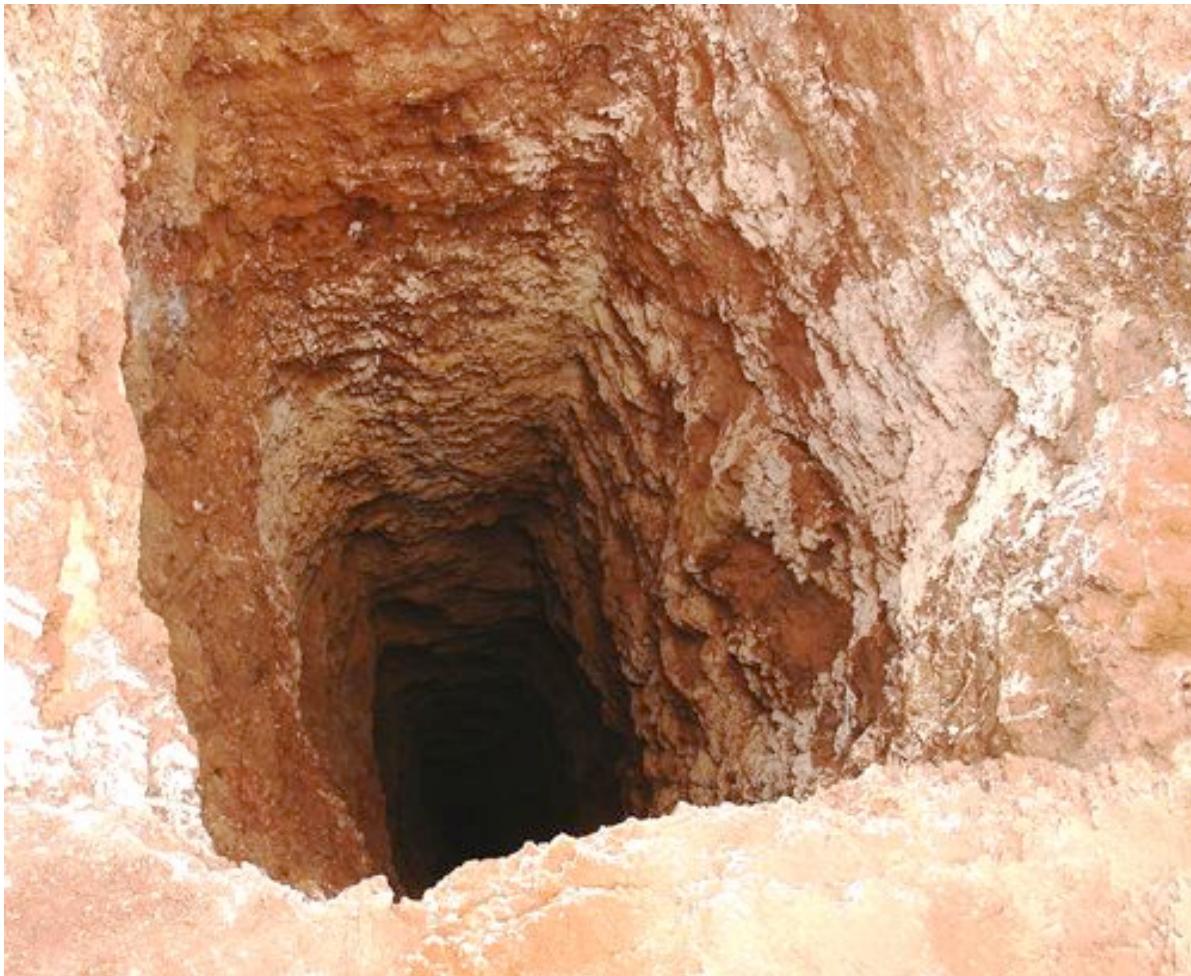
*View Down the Vertical Mine Shaft*

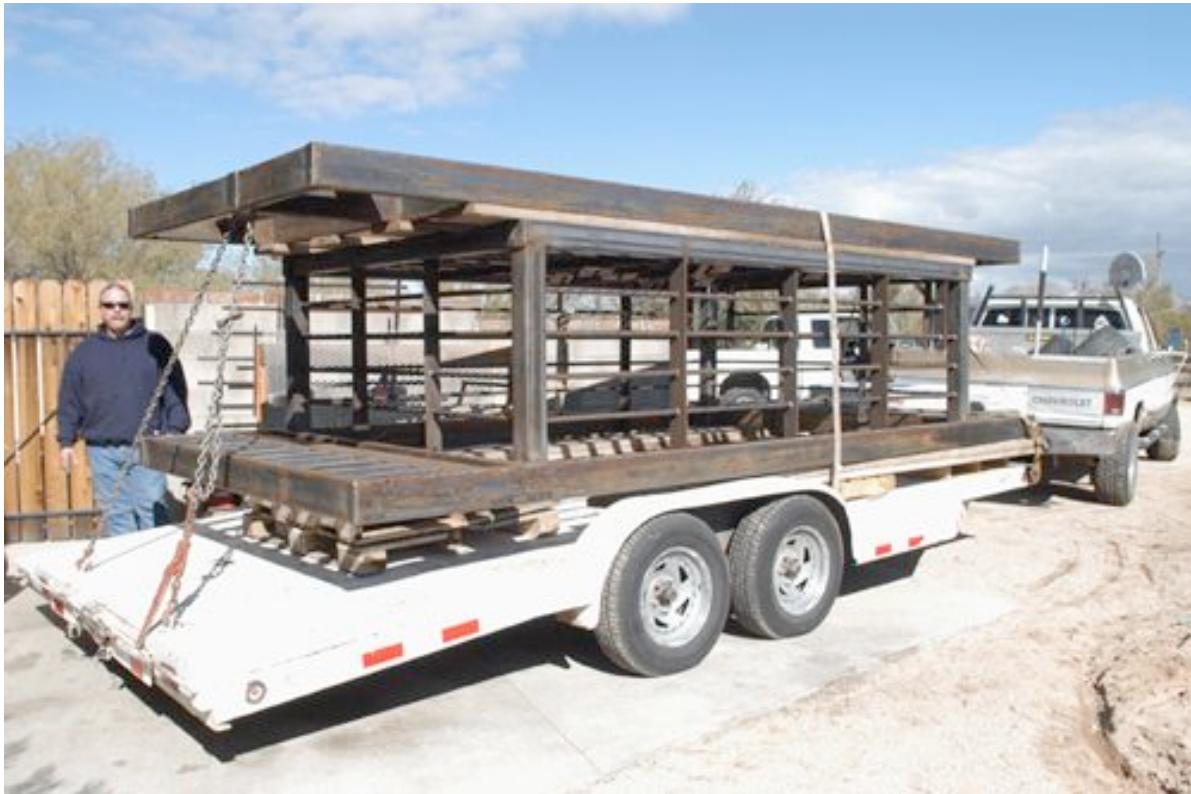
*Gate Loaded on Trailer at the Shop*

Once our gate design was complete we began construction of the gate at our shop in Tucson, Arizona. When possible we prefer to build our gates in a workshop instead of on-site construction. We've found that we can build gates quicker and with higher quality in a shop. Due to the size of this gate we decided to build the gate in three sections. This also made the gate small enough for trailer transport to the mine site. Weighing in at around 5,000 pounds we used our shop's chain hoists to move the gate around during construction. Since this gate site was in an area that could be prone to vandalism and attacks we built the gate with heavy materials and two types of steel. The frame structure was built of heavy  $\frac{1}{4}$  inch mild steel. The bars, and bar mounts were built of work hardening Manganal Steel. The result was an extra strong gate that would be very difficult to vandalize.

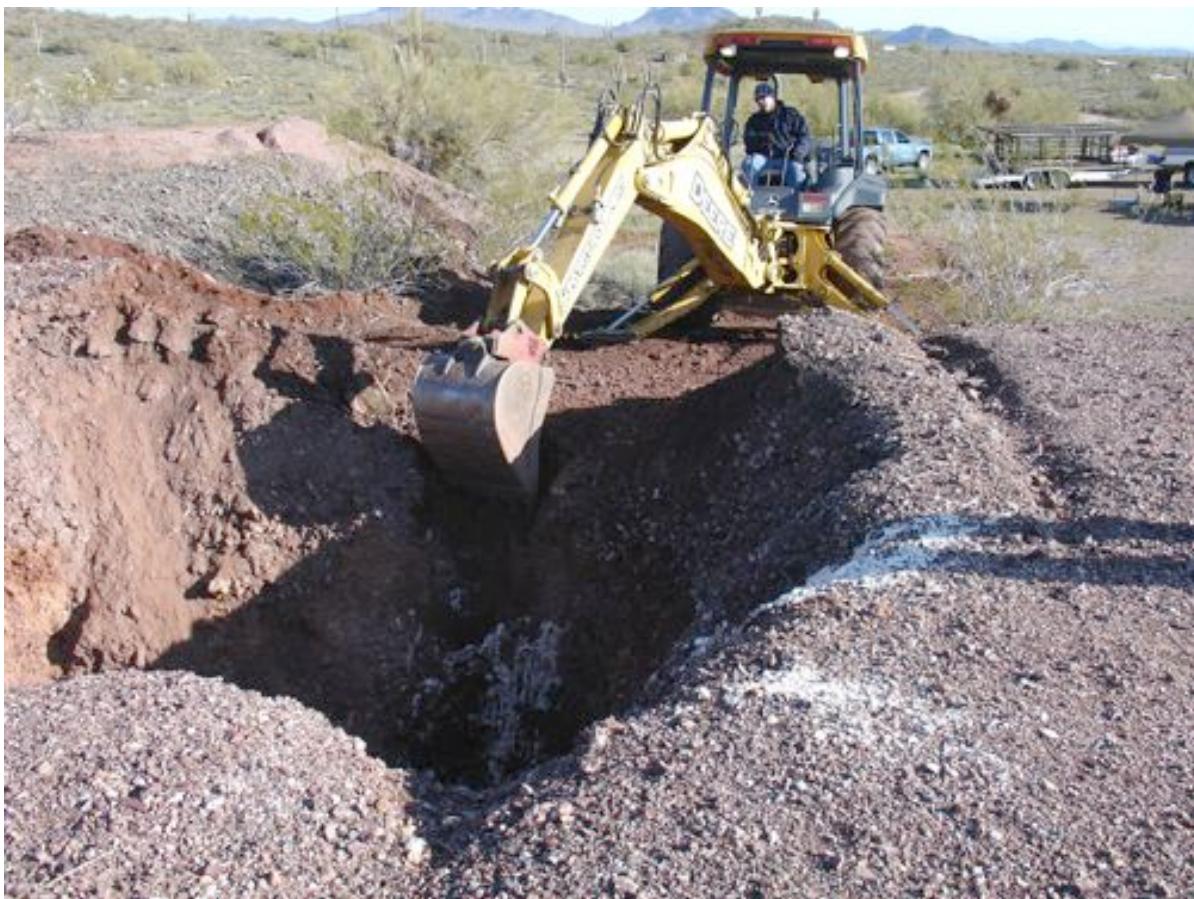
*Careful Backhoe Clearing of Waste Rock Around Mine Shaft Collar*

Work began at the site with the clearing of the waste rock around the collar of the shaft. This work was carefully done by our skilled backhoe operator Bruce Lynn, as we had to move the waste rock and dirt away from the mine shaft without dumping any into the hole. While we were digging we found pieces of green ore in the rock dump around shaft entrance. The miners were probably mining copper at this site.

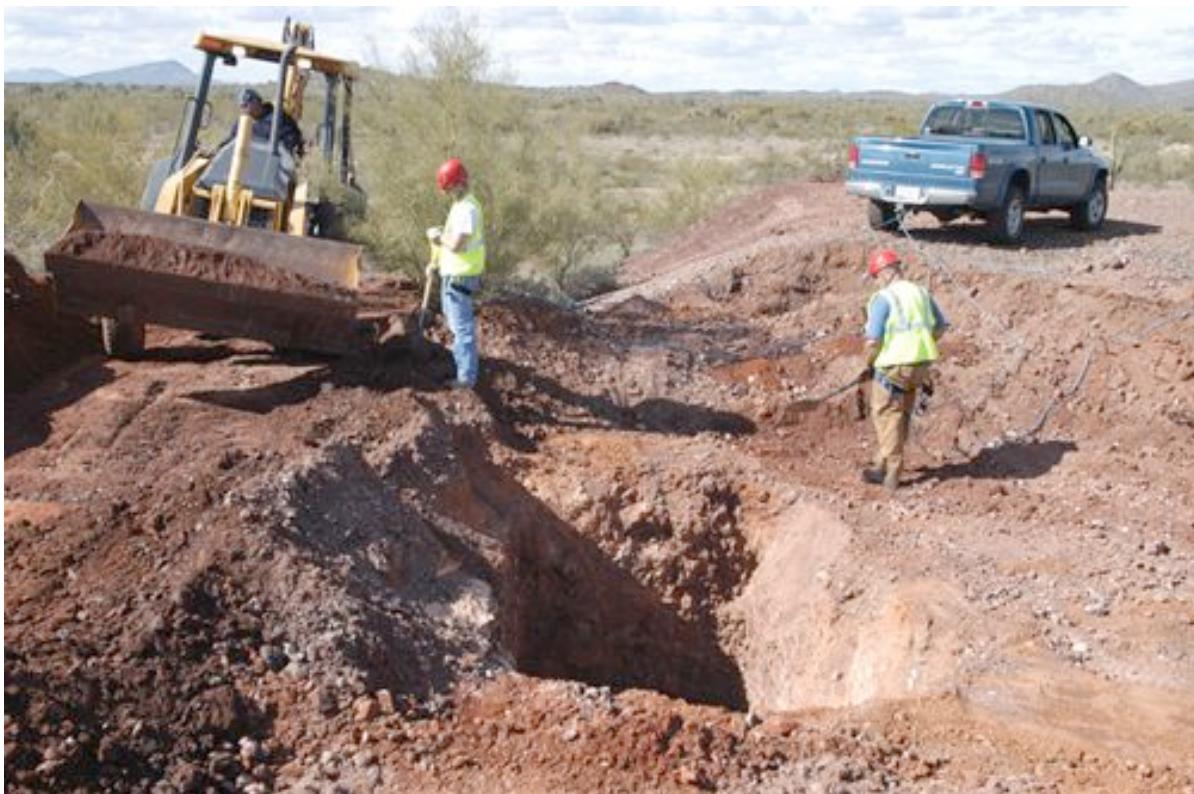
*Backhoe and Hand Clearing of Waste Rock Around Mine Shaft Collar*

Clearing of the waste rock around the collar continued all the way around the shaft. To avoid adjacent vegetation and the historic concrete winch foundations, our backhoe could only operate from limited positions around the pit. In these sections we dug out much of the waste rock with hand shovels. Notice that the workers who are near the open shaft are roped in with climbing harnesses and wear rock climbing helmets. Since natural rigging points were scarce at this site, we rigged our ropes directly to one of our

work trucks. If one the workers accidentally fell into the shaft they would be quickly stopped by the rope and would be able to easily ascend out of the pit. Also note the high visibility yellow safety vests. These bright colors make it easy for the backhoe operator to see the workers. Safety is extremely important on our projects. We try our best to be thoughtful about every action, and take our time doing our work so that it is done correctly, and in a safe manner.

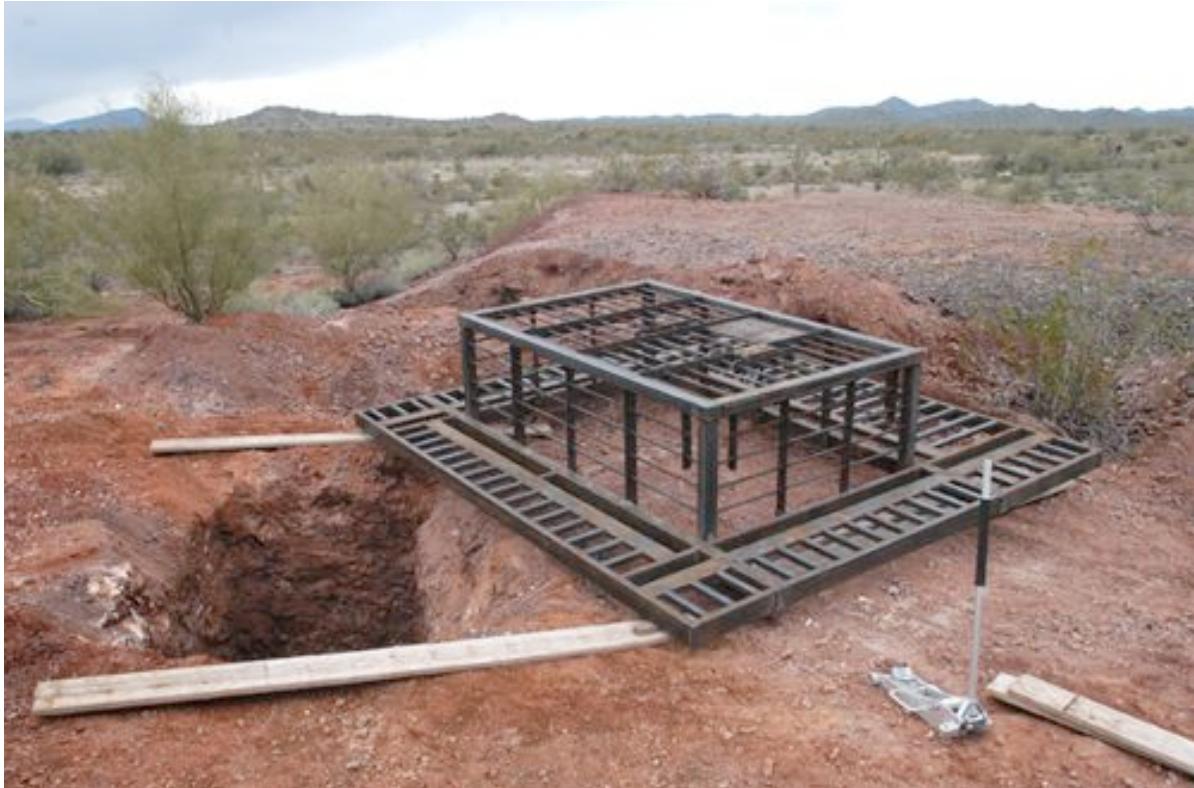
*Placing Cupola Gate over the Mine Shaft*

Once the three sections of the Cupula Gate were welded together we used the trailer to move the assembled gate next to the mine shaft. By using a combination of two chains, a 3-ton floor jack, wooden pallets, two trucks, and the trailer, we were able to place the finished gate onto skid boards directly adjacent to the mine shaft. We then slid the gate into the final position with chains attached to the work truck and the backhoe.

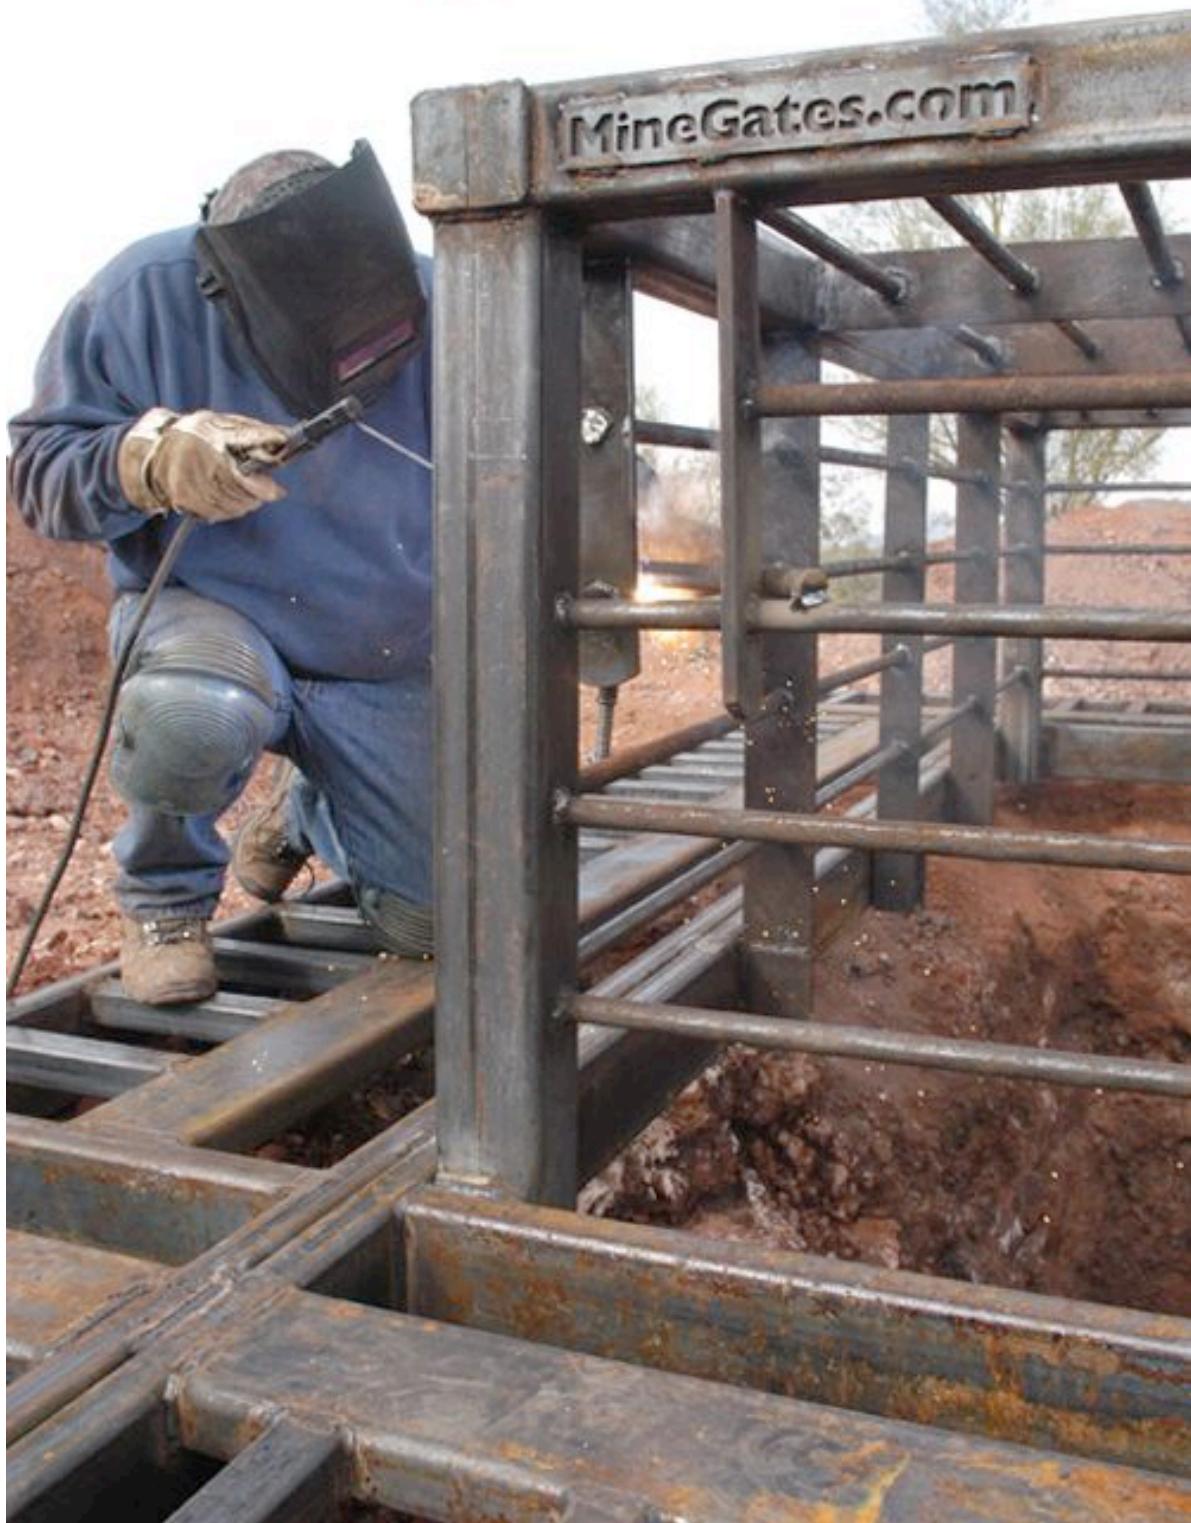
*Final Cupola Bat Gate Welding*

With the Bat Gate in place we next drilled one-inch diameter holes around the perimeter of the gate apron. These holes were drilled about one foot deep into solid rock. Next we drove steel mounting pins into the rock to ensure that the gate could not be easily moved. For added stability the pins were then welded to the edge of the gate apron.

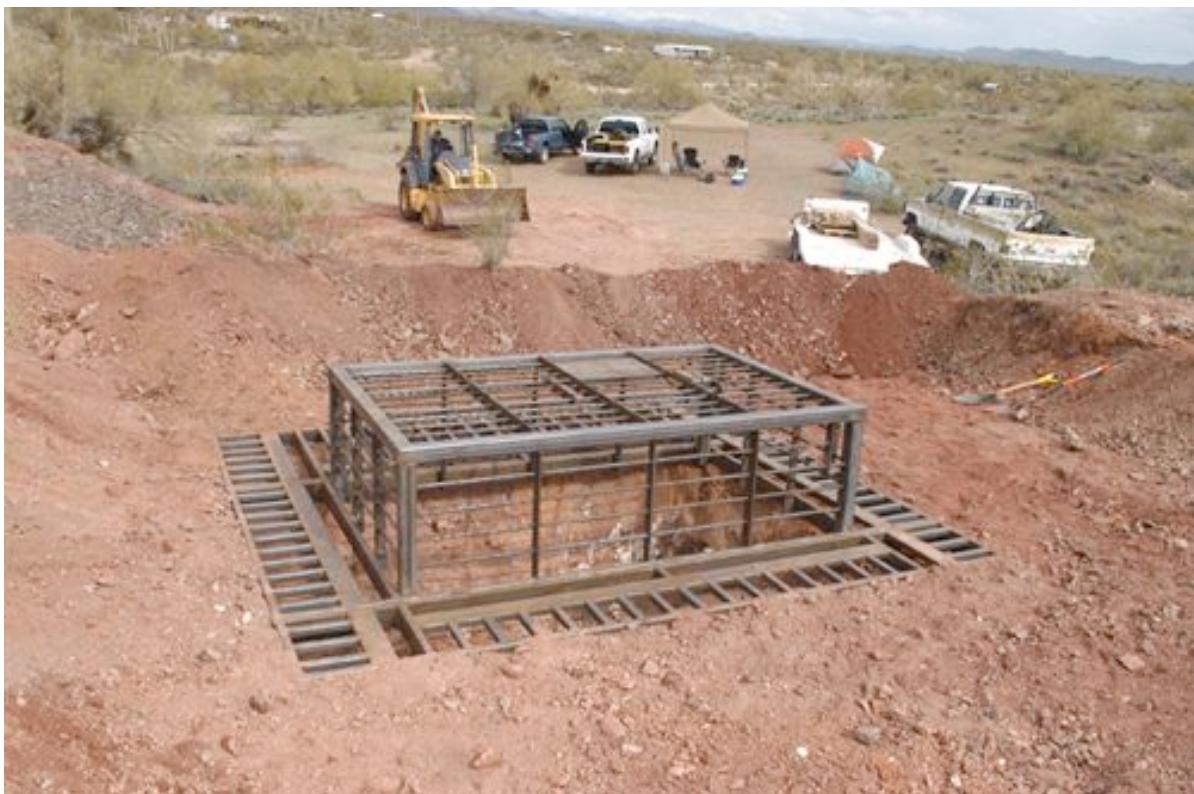
*Installed Cupola Bat Gate*

Once the final welding and positioning was complete, we backfilled the edge of the gate apron so that the surface would be flush with the base of the gate. This further helped stabilize the gate and controls water runoff from undermining the structure. Our final work included building a dirt/rock berm around the gate area so that the entire structure was mostly hidden from view. From the nearby roadway, the site looks the same as it did before we installed the gate.
